The emergency ceiling repair project at The Assembly Rooms, undertaken in 2017, was a complex and challenging project and we were delighted with the positive and proactive attitude displayed by all the contractors involved. The main piece of work was the replacement of the Great Assembly Room ceiling. This work was undertaken by the skilled craftsmen of Ornate Interiors, who worked tirelessly and diligently under difficult conditions to replace the full lath and plaster ceiling using exactly the same materials and techniques used when the ceiling was first erected in the eighteenth century. It was an immense achievement to complete the project to a very high standard in such a tight window of time.

The Assembly Rooms in Blake Street, York, were completed in 1735, some 36 years earlier than the famous Assembly Rooms in Bath, and are probably the earliest example of neo-classical architecture in Europe. They are therefore of considerable importance and a Grade I listed building.

Section through ceiling construction

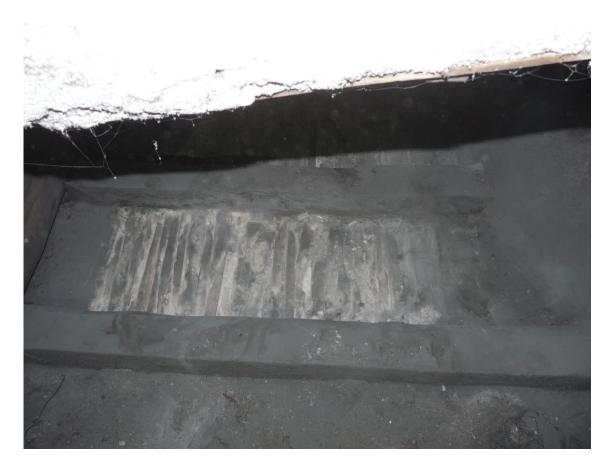
Above: The original ceiling in need of replacement due to warn out plaster not being secure. Right: The stages of the new lath plaster ceiling.

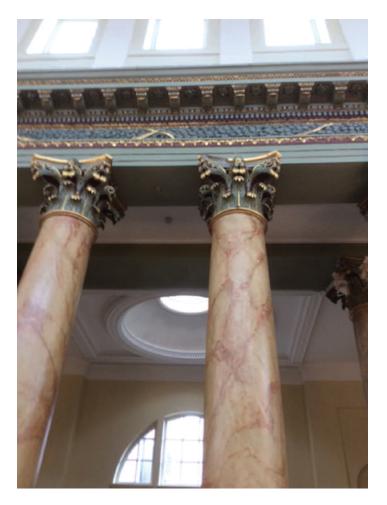
The damaged Corinthian Capitals prior to repair.
