CASE STUDY: The Leeds Grand Theatre & Opera House

Client: Leeds City Council

- Survey of the plaster in the auditorium ceilings and balcony fronts
- Detailed report on condition and budget rates for repairs
- Subsequent completion of all repairs required
- Issue of Ceiling Safety Certificate

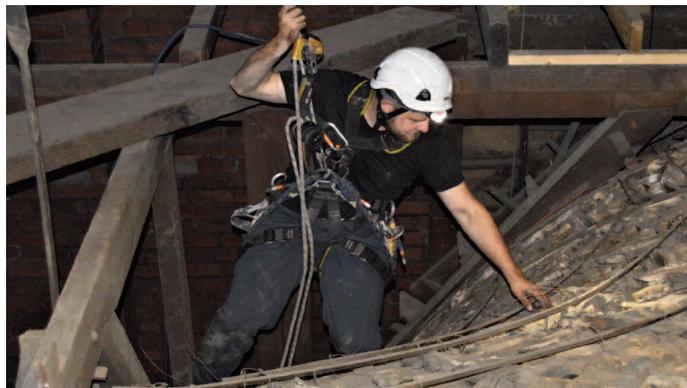
Paul from Ormate Interiors checking 1878 open fret work cast plaster panels forming Gothic Fan Vaults at the corners of theatre ceiling
